# **SPILL PREVENTION AND STORMWATER CONTROL PLAN**

**MOAB SALT, INC.**

POTENTIAL FOR BRINE SEEPAGE ALONG ROCK FRACTURES,  
BRINE LAKE STORAGE AREA,  
CANE CREEK MINE, GRAND COUNTY, UTAH

Prepared by  
EARTHFAX ENGINEERING, INC.  
SALT LAKE CITY, UTAH

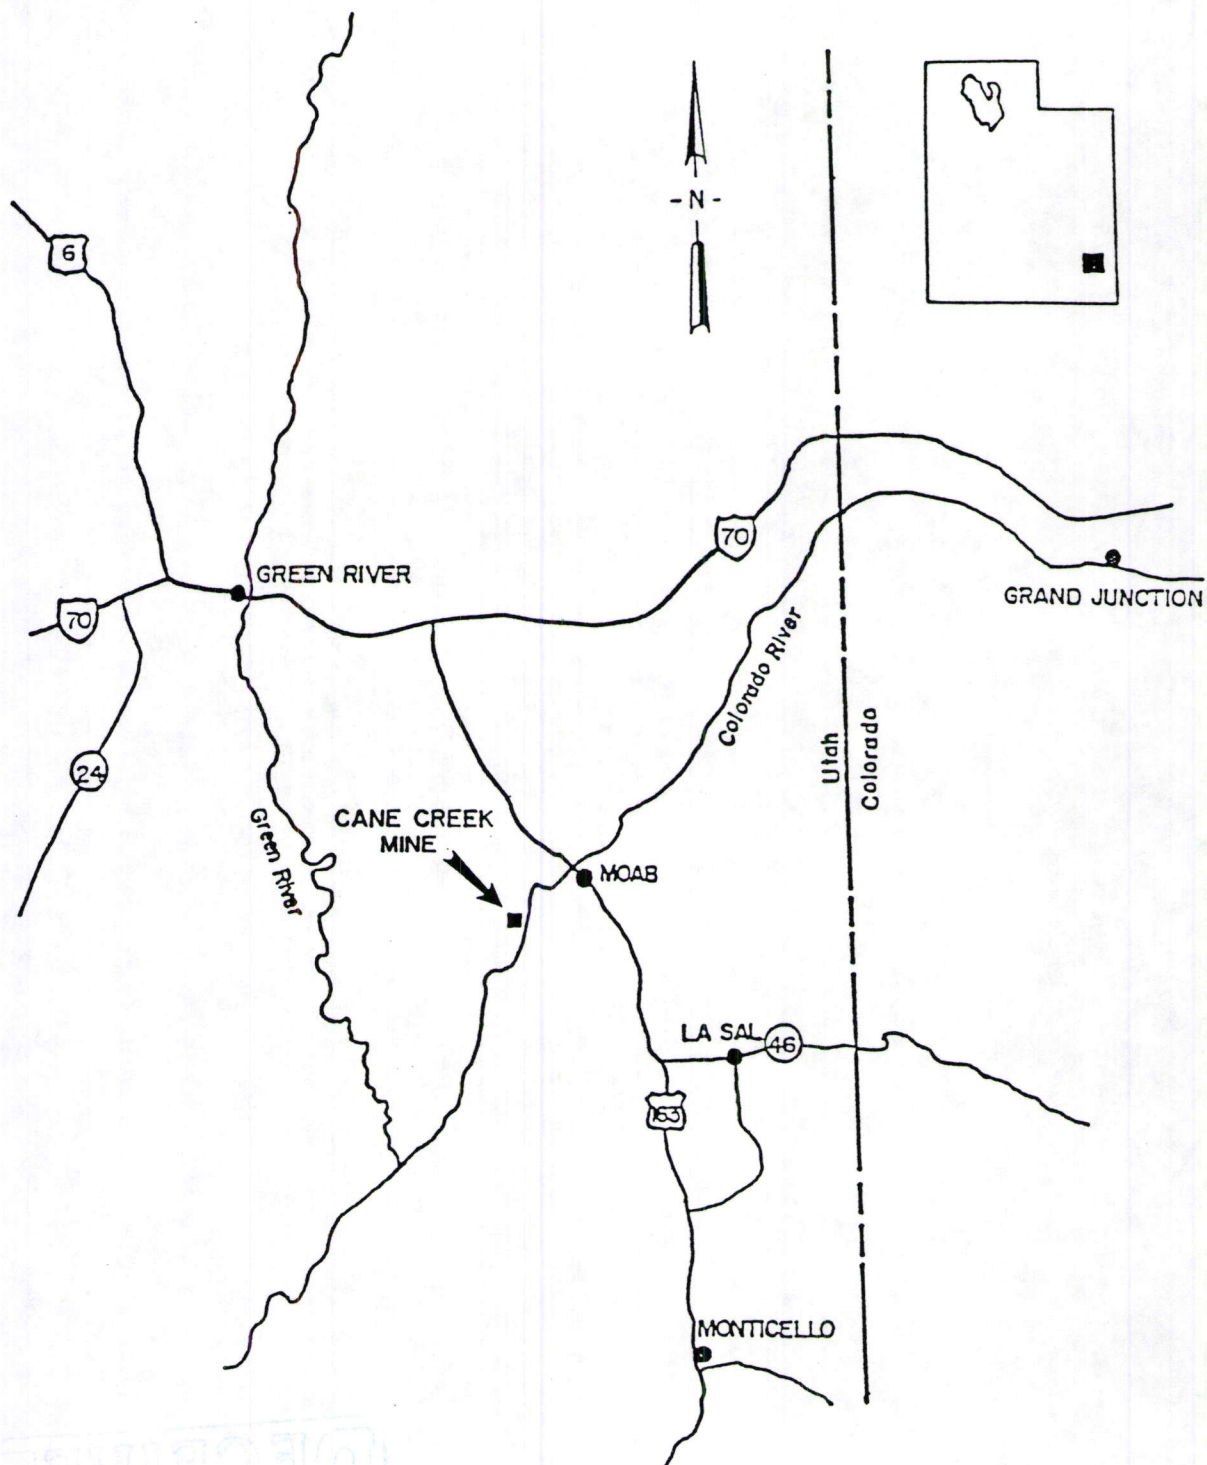
Figure 1. General Location of the Cane Creek Mine.

This report presents results of a surficial geologic field investigation and a very-low-frequency electromagnetic (VLF-EM) survey of bedrock fractures at the Cane Creek Mine, Grand County, Utah (Figure 1). The emphasis of this report is directed toward a study of fractures which underlie Moab Salt's brine storage lake and those fractures associated with the brine lake dam abutments and spillway (Figure 2). This study was undertaken in response to written comments prepared (1/28/88) by the Utah Division of Oil, Gas and Mining (DOGM) concerning the potential of fractures which underlie the brine lake to transmit brine to off-site areas. Moab Salt, in written response (5/18/88) to DOGM comments, agreed to undertake additional study of faulted and fractured bedrock in the vicinity of the brine lake area to evaluate the potential for brine seepage toward the Colorado River.
